# TECHNICAL INFORMATION

TI0521

SiLine Snack S/M

## Loud operating noise

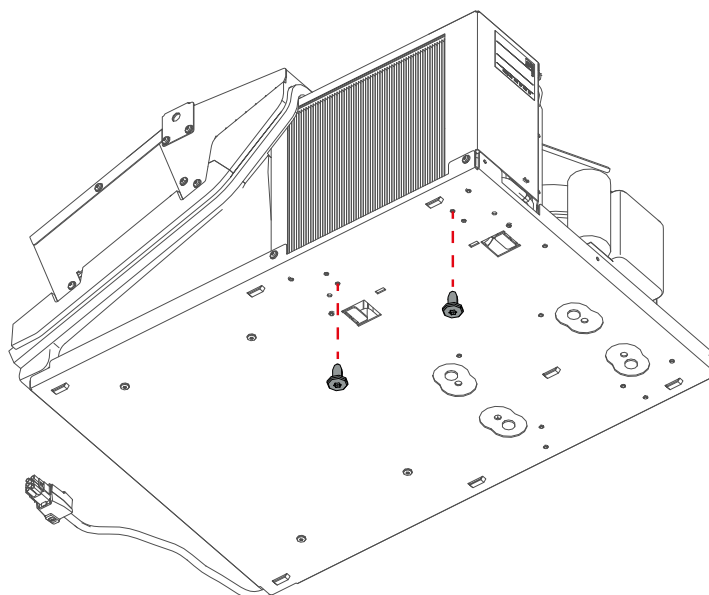
In rare cases a loud noise may occur in SiLine Snack machines during operation. This is caused by the condenser in the chiller unit having moved from its installation position. The displaced condenser causes other components to vibrate.

We recommend securing the condenser using two threaded screws M5 x 10. This prevents the condenser from moving and ensures quiet machine operation.

This problem has been rectified on all condensers supplied from the factory since March 2021.
